Building Inspection Report

7777 East Inspection Drive, Anytown, AK Inspection Date: 06/28/2013

Report Number: 1300000

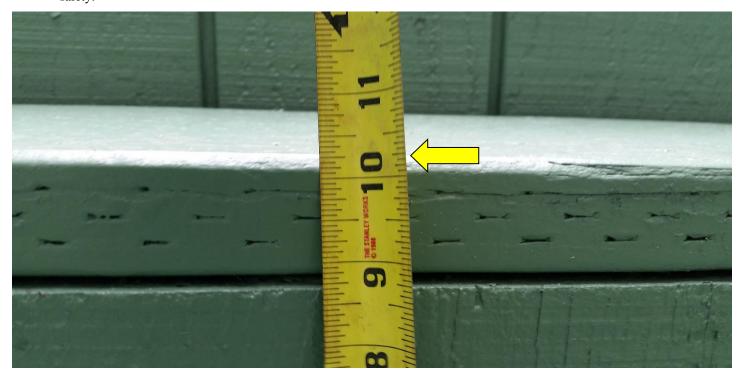
Rear Exterior Stairs

• **Safety Issue, Repair**: The size and/or orientation of the stairway "risers", on both sets in the rear, may make the stairways difficult to negotiate. The maximum riser height should be no more than 7 ¾". More importantly, extreme variation in riser height (in this case 4 ½" and 1 ¼" respectively) can cause a "trip" hazard. These conditions should be corrected for improved safety.

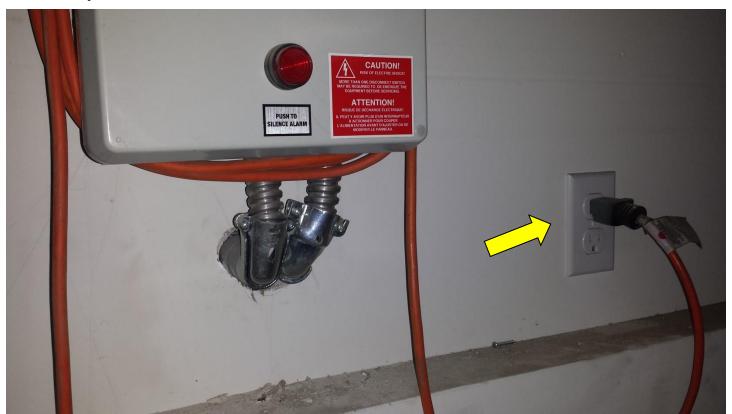
GFCI Garage Circuit Needed

• **Safety Issue, Repair:** None of the receptacles in the garage appear to be GFCI protected. All garage receptacles should be GFCI protected.

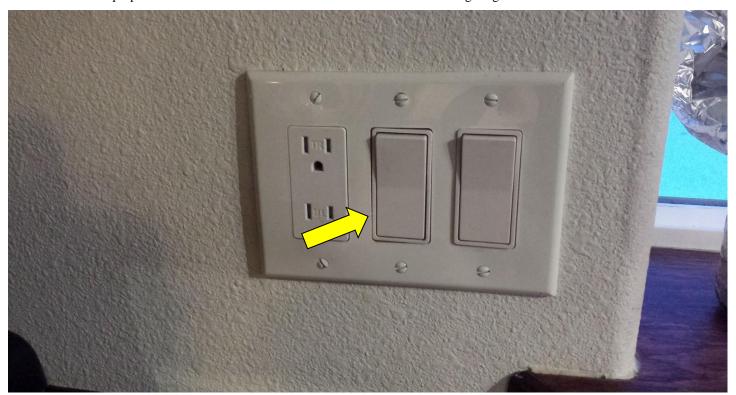
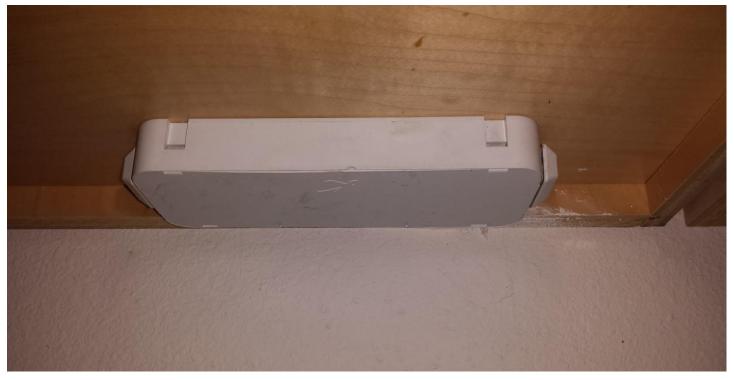
Unidentified Light Switch

• Improve, Repair: One of the light switches in the kitchen didn't appear to be connected to any fixture. It is possible that this switch was designed to activate (yet to be installed) lighting under the cabinets. The homeowner should be consulted to determine purpose of the switch and the brand/model of the under-cabinet lighting.

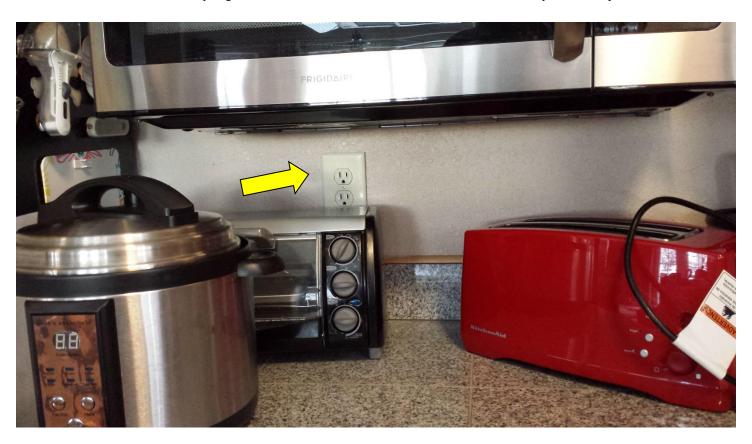
GFCI Protected Receptacles

• Safety Issue, Repair: The receptacle under the microwave should be GFCI protected. The same is true of the receptacle to the right of the bathroom vanity. Additionally, the GFCI receptacles in most of the baths did not appear to be wired properly. Our tested indicated an "open ground". These issues should be examined and corrected by a licensed professional.

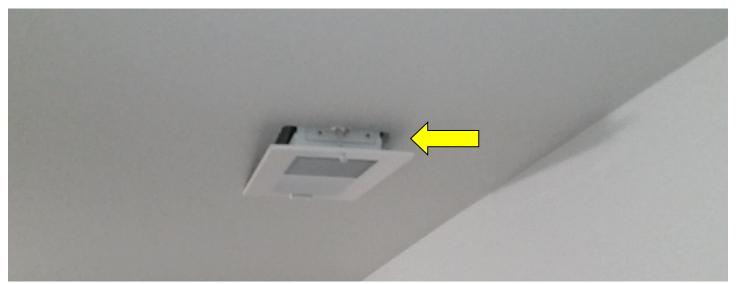
Heat Register

Improve, Repair: The heat register, downstairs at the bottom of the stairs, is coming loose from the ceiling.

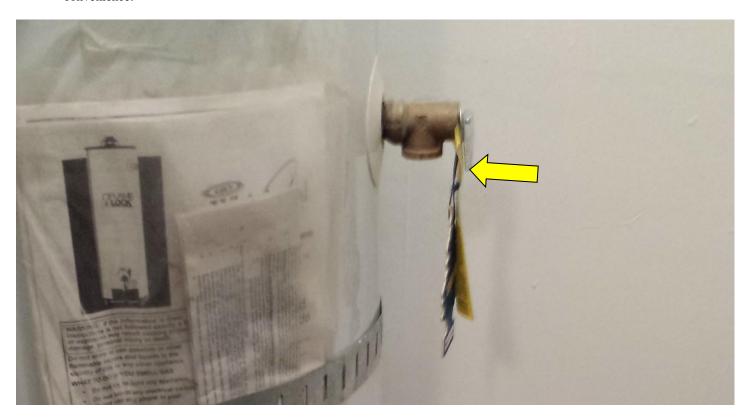
Pressure Relief Discharge Tube

• **Safety Issue, Repair:** The water heater is missing a pressure relief discharge tube. This tube should be attached to the pressure relief valve and should extend to within 6 inches of the floor. This issue should be corrected at the earliest convenience.

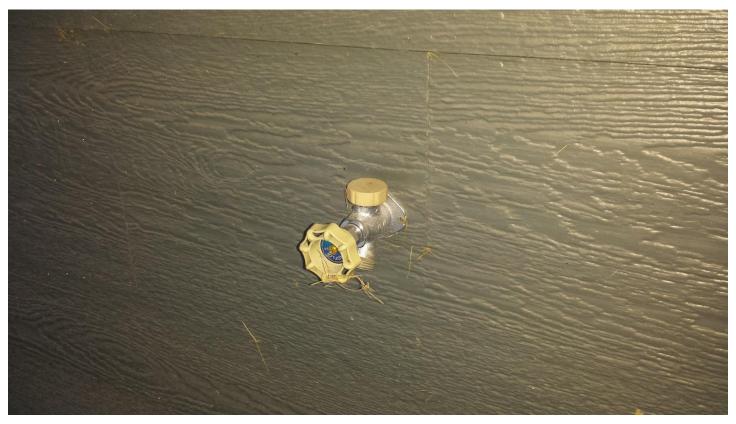
Outdoor Water Hose Bibs

• **Improve, Repair:** Two of the exterior hose bibs did not function during our visit. They may have been shut off internally for winter. The homeowner should be consulted to determine where the shut off valve is located.

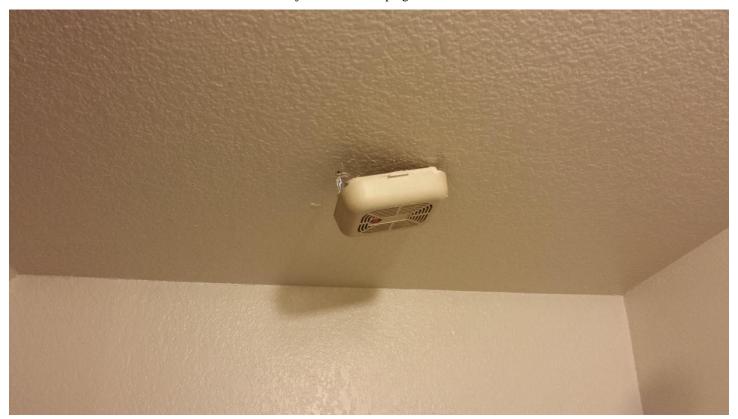
Smoke and Carbon Monoxide Detectors

• Safety Issue, Repair: Some of the home's smoke detectors were either missing or not functioning. Each bedroom or sleeping area, and the common area adjacent to sleeping rooms must have a functional smoke detector. The home should also have a CO detector on each level and adjacent to the sleeping areas.

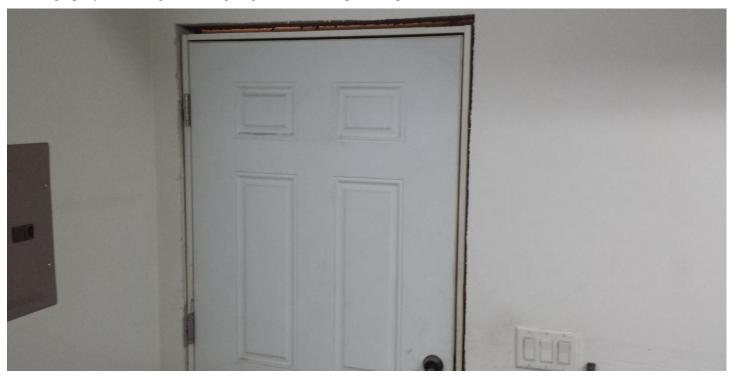
Garage "Fire" Door

• **Safety Issue, Repair:** The door separating the living area from the garage must be fire-rated, sealed properly, and have properly functioning self-closing hinges to ensure adequate fire protection.
